DEPARTMENT OF DEFENCE
DEFENCE SCIENCE AND TECHNOLOGY ORGANISATION
MATERIALS RESEARCH LABORATORIES
MELBOURNE, VICTORIA

MRL-R-1060

AN EXAMINATION OF COATING FAILURE ON WING PIVOT FITTINGS
OF F111 AIRCRAFT

L.V. Wake

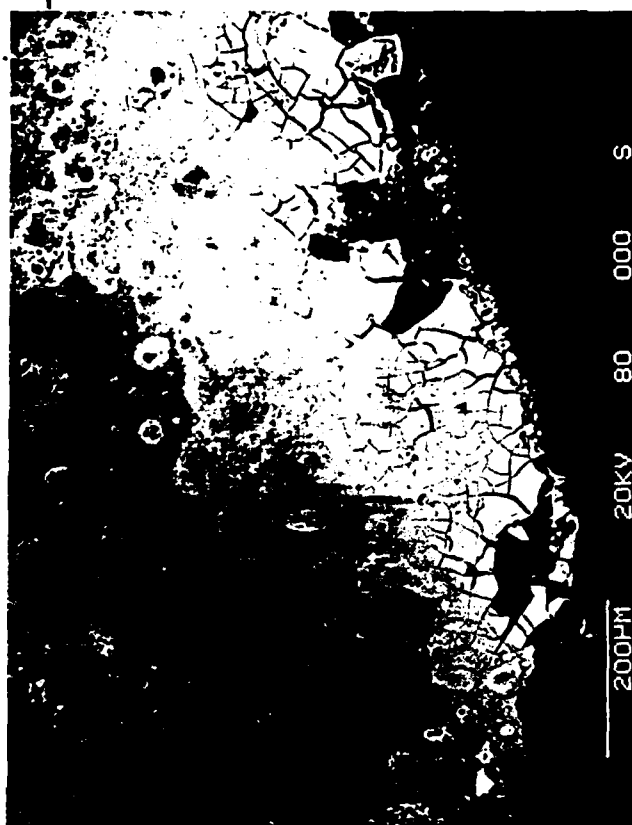
A further problem causing coating failure on the pivot fittings was breakdown of the original vapor deposited cadmium. This failure occurred on one of the upper stiffeners on aircraft A8-114. The cadmium had reacted with a sulphur material, presumably the sulphur present in Brisbane fuel, and the product had detached removing the overlying original PR1563 polyurethane paint with it. The cadmium/sulphur reaction product was relatively thick along one edge of the failure (Fig. 8). (A similar failure occurred under paint and sealant in a wing tank as a result of breakdown of the vapour deposited cadmium. In this case the reaction product was a cadmium/phosphorus compound (Fig. 9)).

Breakdown of the vapour deposited cadmium on the stiffeners was a small and isolated failure. The cadmium reaction products on the failed coating were thicker on one side of the blister and gradually diminished across the failed area. It is believed that this failure occurred adjacent to a blistered rework area of the fitting exposing the edge of the cadmium to the fuel. The failure of the vapour deposited cadmium that occurred elsewhere in the wing fuel tank is more complex as these areas are frequently scratched by the dental picks and probes used to remove sealant during the deseal/reseal process. Whatever the mechanism of the failure, it is apparent that the cadmium has been exposed to HiTech 515. The characteristic morphology of the cadmium/phosphorus complexes resulting from the reaction of the phosphorus material in HiTech 515 with cadmium had earlier been observed on components in aircraft fuel systems by Sanders et al (15).

Fig 8. Cadmium/sulphur reaction product. The thickness of the product is much heavier adjacent to one side of failed paint flake. (Silicone peak from filler in coating). Aircraft A8-140.

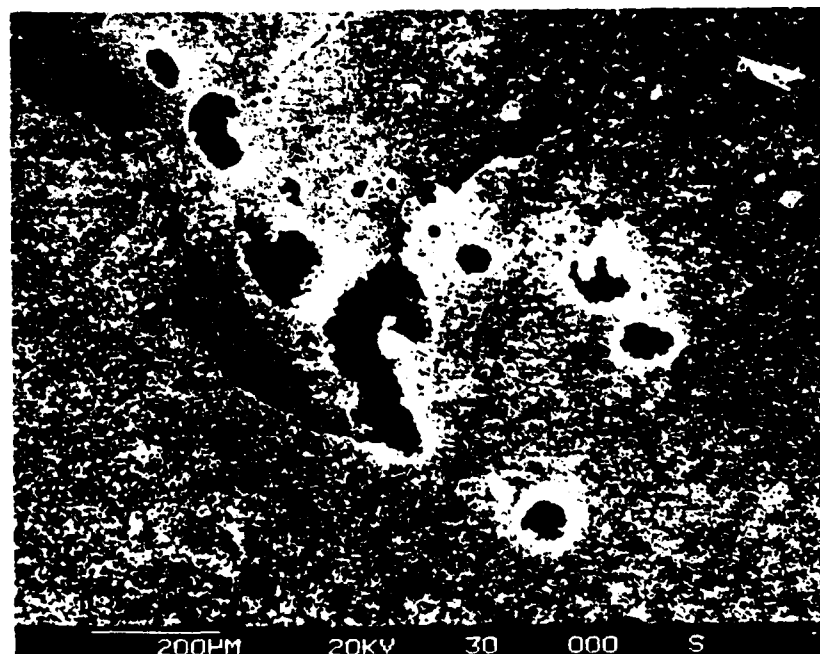
Following priming of the inspection areas, it is apparent that these and all other surfaces inside the wing tanks, the wing carry-thru box and other fuel tanks were resprayed with the replacement topcoat to provide a uniform coating appearance. This practice has been confirmed by the relevant Service personnel. Widespread adhesive paint failures have occurred with this repair scheme, resulting in detachment of the oversprayed polyurethane topcoat from the original fuel resistant topcoat away from the inspection areas of the pivot fittings (Figs. 4 and 5). The condition of the failed topcoat from the blistered areas shows evidence of binder breakdown (Figs. 10 and 11).

FIG. 11 Advanced paint failure of PR 1563 topcoat. Paint from Aircraft A8-140. Lower surface of paint flake.
